EVALUATION OF THE COMPRESSIVE STRENGTH OF HYBRID AND NANOCOMPOSITES-ORIGINAL RESEARCH

Esthetic correction represents one of the clinical conditions that require the use of composite veneers in the anterior region. Aim of the study is to evaluate the fracture strength of direct veneers in maxillary central incisors fabricated from composites (Direct Technique). Thirty sound human maxillary central incisors were used in this in vitro study. Teeth were randomly divided into three experimental groups of ten teeth each. Group A-Restored with Nano Hybrid (Ceram Spheretec), Group B-Restored with Microhybrid (Tetric n ceram) & Group C-Restored with Direct Composite Veneer(Spectrum). Standard preparations were done using ceramic veneer set and all specimens were stored in distilled water at 37 degree C for 2 weeks. After that the specimens were mounted in a acrylic block. The load was applied on the incisal part of the veneer to the long axis of the tooth using Universal Testing Machine. Results were analyzed with One Way Anova & LSD Tests. Group a showed higher mean of fracture strength with statically significant difference in comparison to group B and group C. All Veneers used in this s

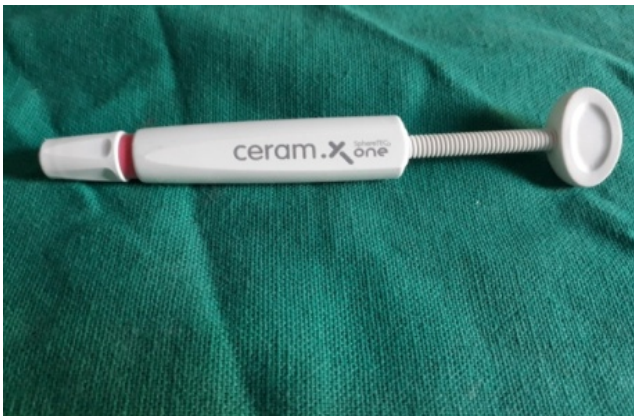
- Group A-Restored with Nano Hybrid(Ceram Spheretec),
- Group B-Restored with Microhybrid (Tetric n ceram) &
- Group C-Restored with Direct Composite Veneer(Spectrum) (fig.2,3,4)

Figure 2: CERAM X SPHERTECH

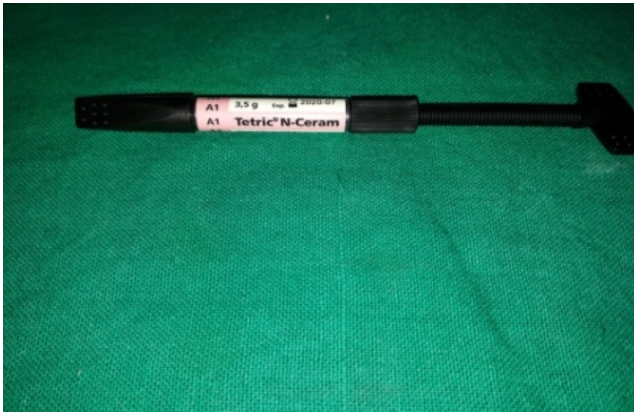
Figure 3: TETRIC N CERAM

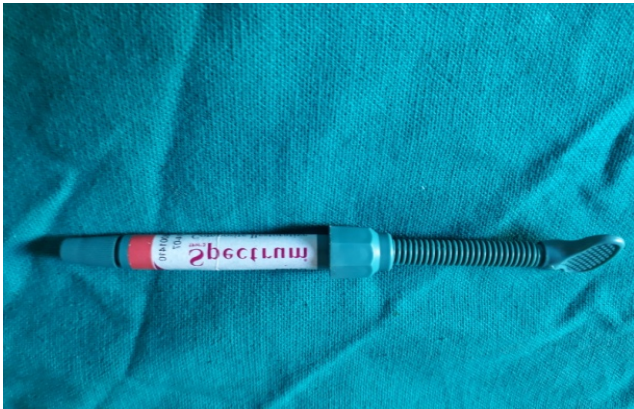
Figure 4: SPECTRUM

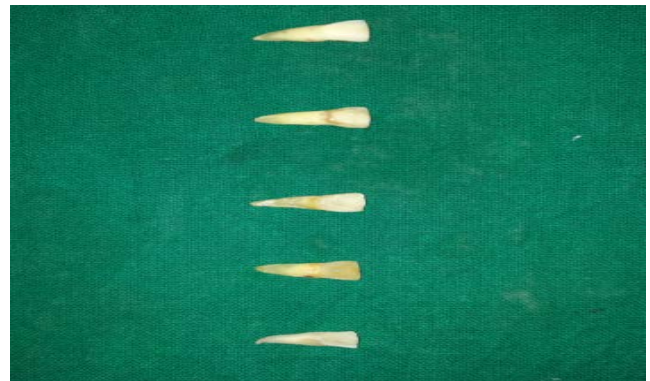
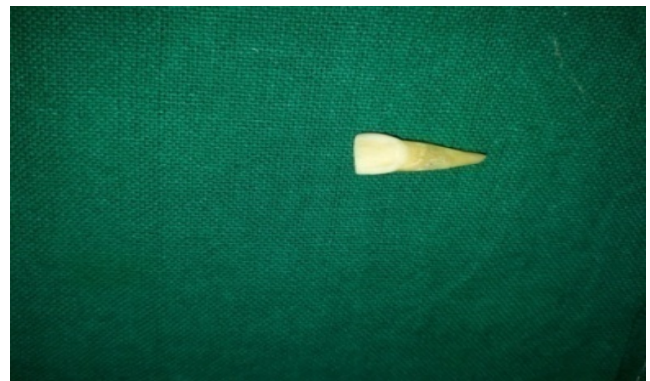
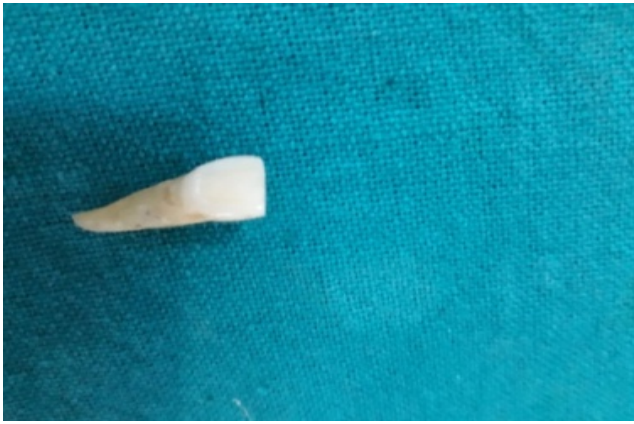
Standard preparations were done using ceramic veneer set.. The teeth were mounted individually in specially designed, locally-manufactured rubber mold (30 mm height × 30 mm diameter) with cold cure acrylic with the long axis of the tooth parallel to center of the mold. Each tooth was suspended in the middle of the mold using a Ney Surveyor (Bego, Germany) to ensure vertical positioning of the tooth inside the mold. All specimens were embedded up to 2 mm apical to the CEJ to simulate the natural biologic width. (fig.5,6,7,8,9,10)

Figure 5: Veneer preparation

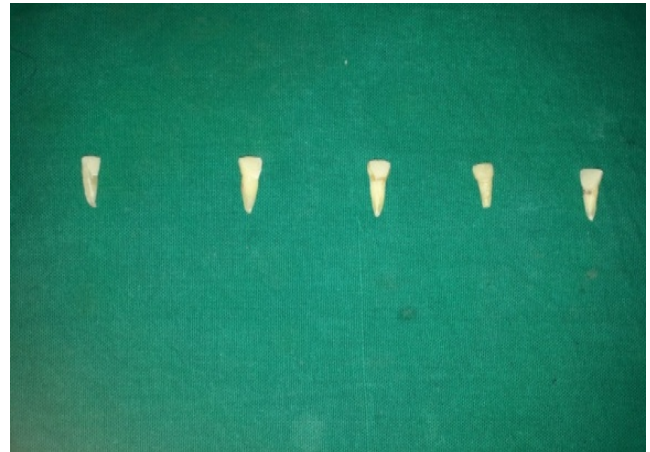
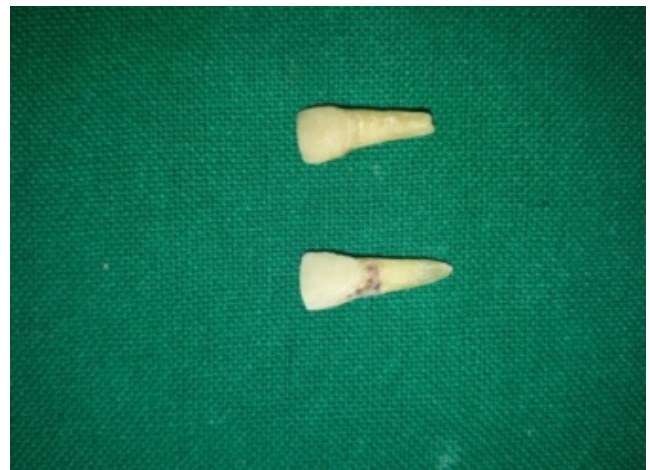
The specimens were then restored with direct composite veneers using Ceram x spheretech, Tetric n ceram and spectrum. The prepared tooth was cleaned with fluoride-free pumice using polishing cup and then etched with 35% phosphoric acid (Scotchbond™ Etchant, 3M ESPE, USA) for 15 seconds, rinse for 10seconds and air dried gently for 5 seconds according to manufacturer's instructions (fig.11,12,13)

Figure 11: Specimens displaying direct veneering with composite restoration

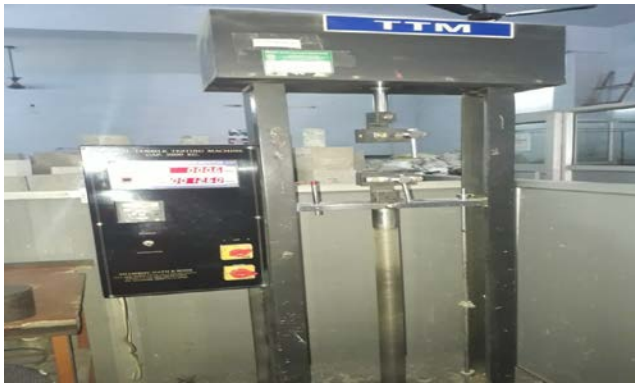
- The veneers were then stored in distilled water at 37 degree C for 2 weeks before testing.
- The fracture strength test performed using a Universal Testing Machine (LARYEE universal testing machine, China).
- Load was applied at a crosshead speed 0.5 mm/min with a customized plunger (steel rod with a flat end 3.6 mm diameter) attached to the upper movable compartment of the machine placed at the facial part of the veneer.
- The load was applied at 45° to the long axis of the tooth. This orientation was standardized with a specially designed, locally manufactured, mounting jig .
- The maximum load to produce fracture for each sample was automatically recorded in Newton (N) using computer software.
- The results of this study were analyzed with one-way ANOVA and LSD test.

Figure 14: Universal testing machine

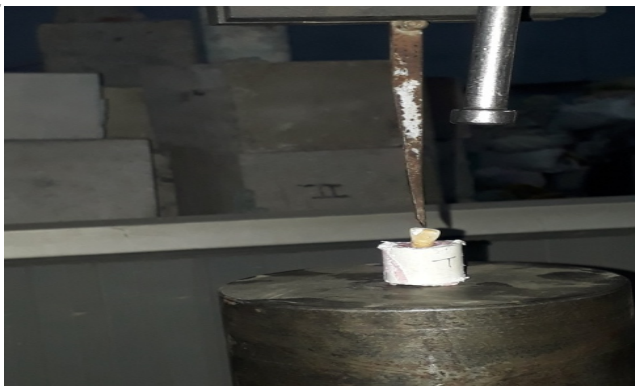
Figure 15: Load applied over the prepared tooth

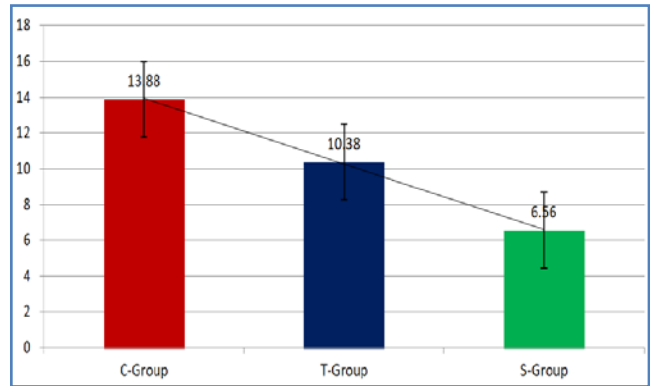
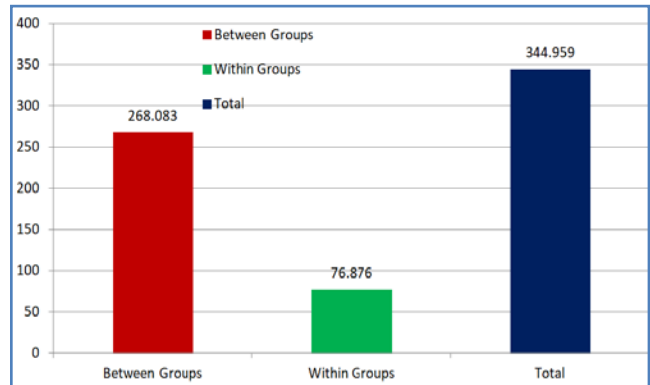
Graph 1:

- *The results of this study showed that the highest mean of fracture strength was recorded for Group A, followed by Group B and Group C respectively.*

- *ANOVA test revealed statistically highly significant differences among the three groups*
